**U.S. DEPARTMENT OF COMMERCE**  
National Oceanic and Atmospheric Admin.  
NATIONAL OCEAN SERVICE  
Office of Response & Restoration  
Assessment & Restoration Division

**TO:** T/V *Margara* Incident Administrative Record

**SUBJECT:** Extraction graphics provided by Alexakos and Simpson, Inc. on May 10, 2006

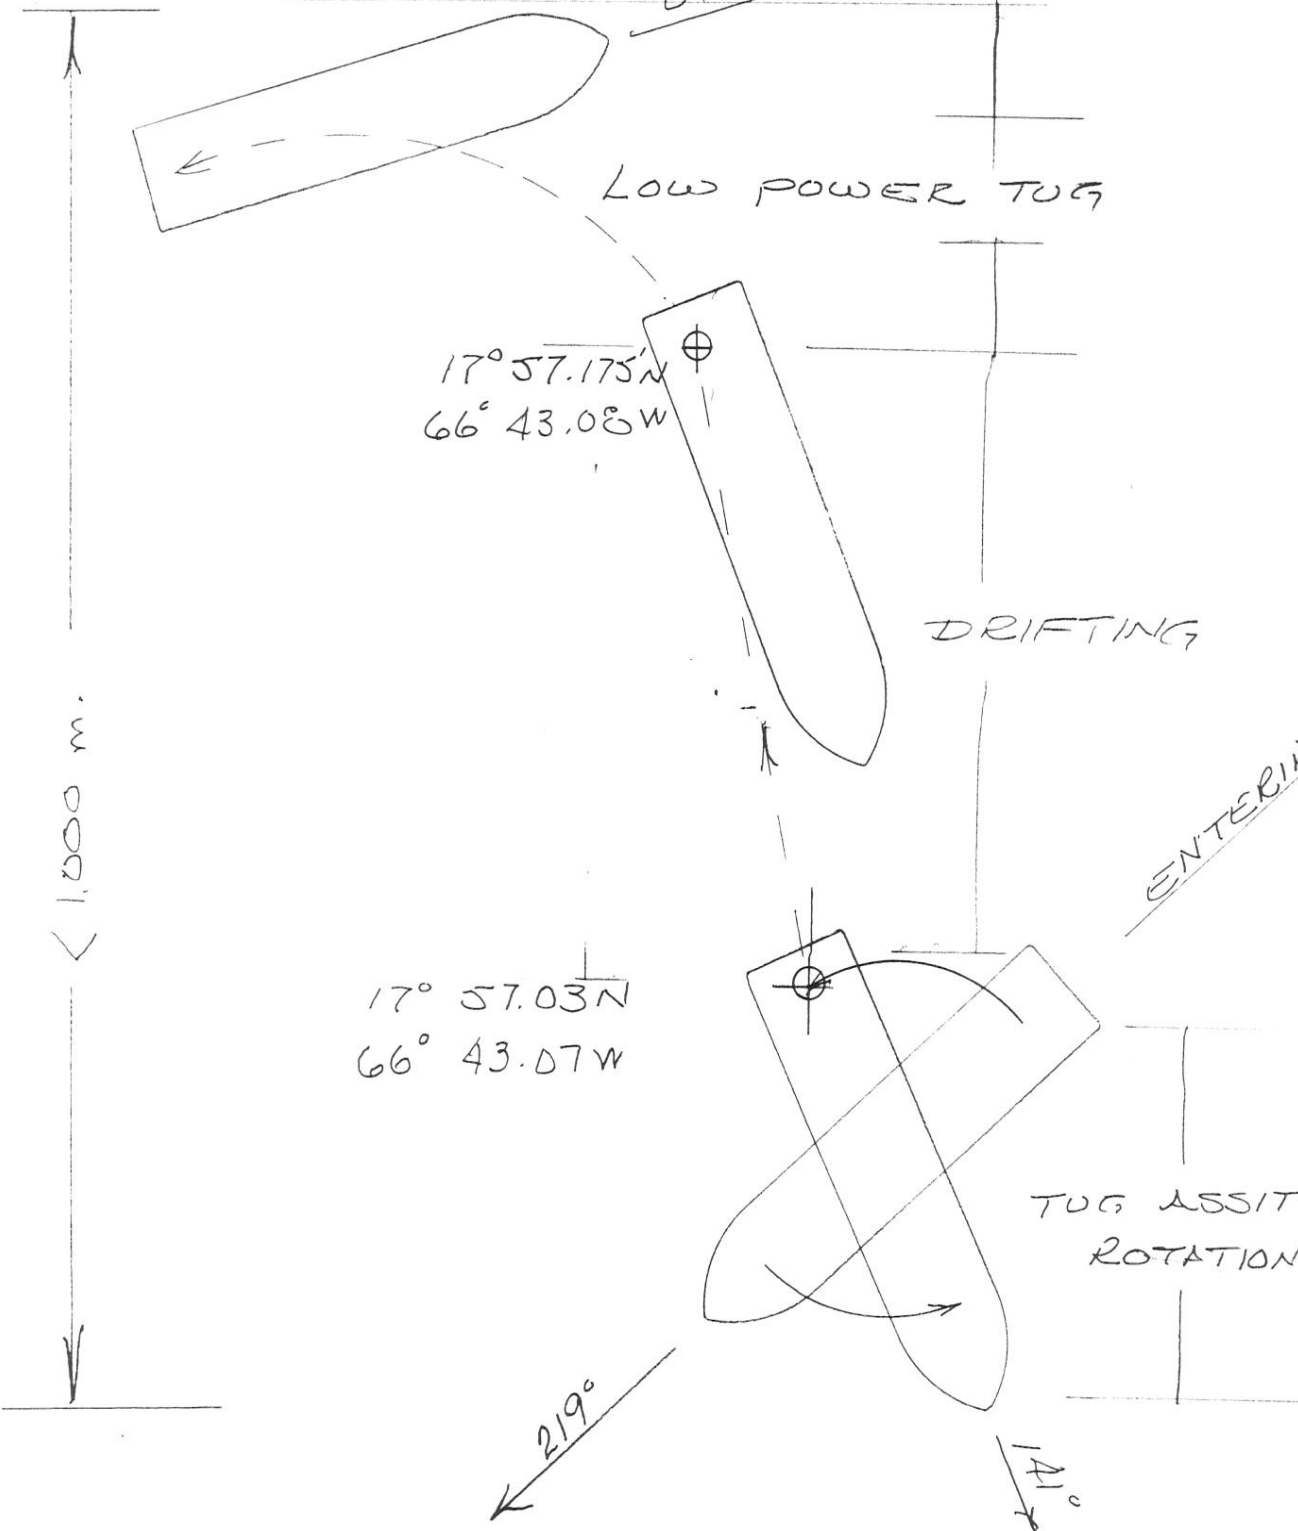
"MARGARET"  
27 APR 06

Capt. Simpson's provided and used these two graphics in explaining how the T/V *Margara* was extracted with tug assist after grounding on April 27, 2006. The first graphic, labeled "MARGARA 27 APR 06" and on Alexakos and Simpson, Inc. letterhead (Graphic #1), is Capt. Simpson's illustration of the position and bearing of the ship as it was extracted along 1000 linear meters by Simpson's estimates. Capt Simpson indicated that the positions on this graphic were taken from the vessel's GPS. The second graphic is Capt. Simpson's illustration of the grounding location and extraction overlaid on a portion of NOAA Chart 25681, 16<sup>th</sup> Ed. Apr 03. This graphic includes dates and times for the vessel position at the time of initial grounding and through the extraction.

**NOTE REGARDING GRAPHIC #1:** On the morning of May 11, 2006, PRDNER, NOAA and CSA personnel attempted to locate the areas of impact at the coordinates on Graphic #1. It was discovered that these coordinates did not coincide with coordinates taken by PRDNER staff at the bow of the vessel while it was still aground and, further, corresponded to a location where water was too deep for the ship to have grounded. Upon returning to shore that afternoon, Capt. Simpson was asked about the inconsistency in the reported coordinates by the dive team and advised that he had made an error in transcribing the longitudinal coordinates appearing on Graphic #1. He advised the longitudinal coordinates should have read 66° 43.8'W for the northern position and 66° 43.7 W' for the southern position. Injuries to resources were discovered at the site at the corrected locations that afternoon.
