## **T/V *Margara* Emergency Restoration Inspection October 19-21, 2006**

A site inspection of the emergency restoration efforts led by Continental Shelf Associates and supported by Trustee staff at the impact sites of the T/V *Margara* was conducted from October 19-21, 2006 by the Trustees. The goal of the inspection was to determine if any additional work was required. The inspection team consisted of Craig Lilyestrom and Edwin Rodriguez (Puerto Rico Department of Natural & Environmental Resources), Michael Nemeth and Sean Griffin (Lighthouse Technical Consultants, Inc.), and Tom Moore and Kevin Kirsch (National Oceanic & Atmospheric Administration).

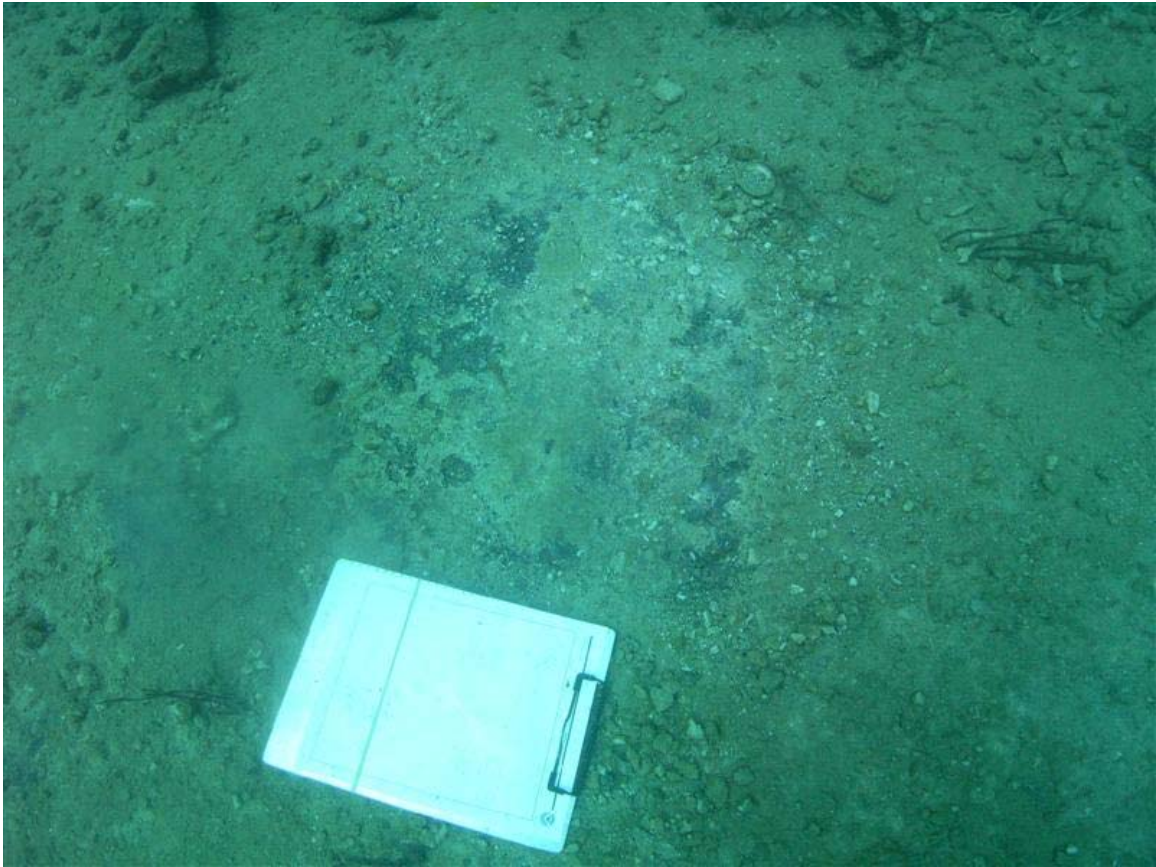
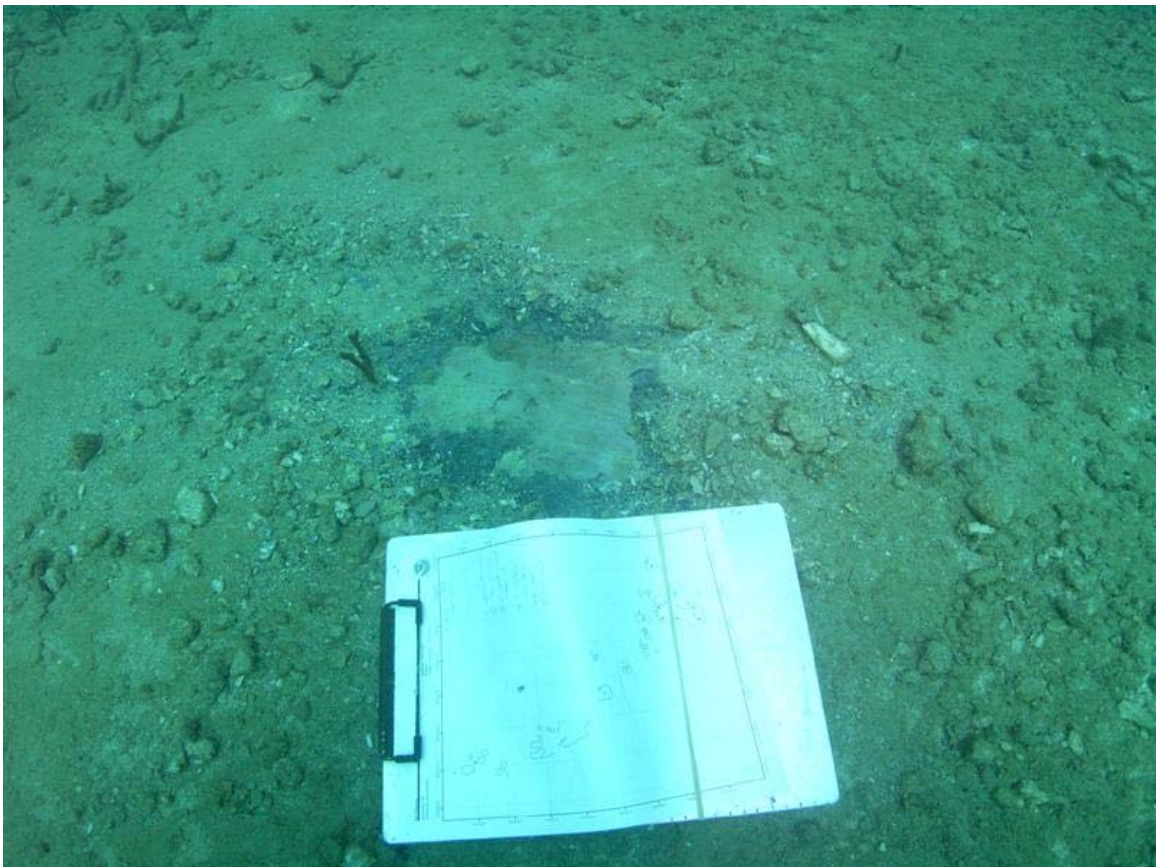
There are at least 5 areas where anti-fouling paint needs to be removed (see Figure 2a & b).

Figure 2a. Representative photos of remaining areas of anti-fouling paint at Site 146

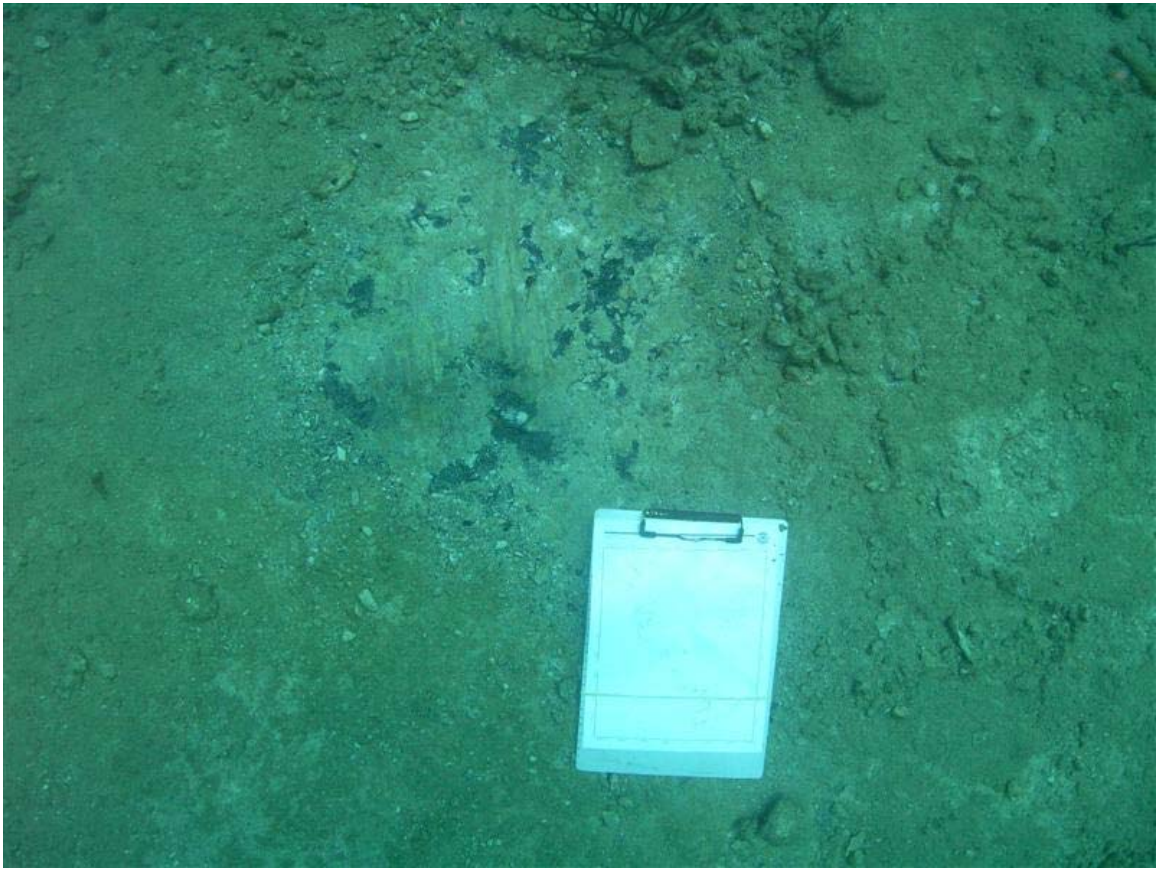
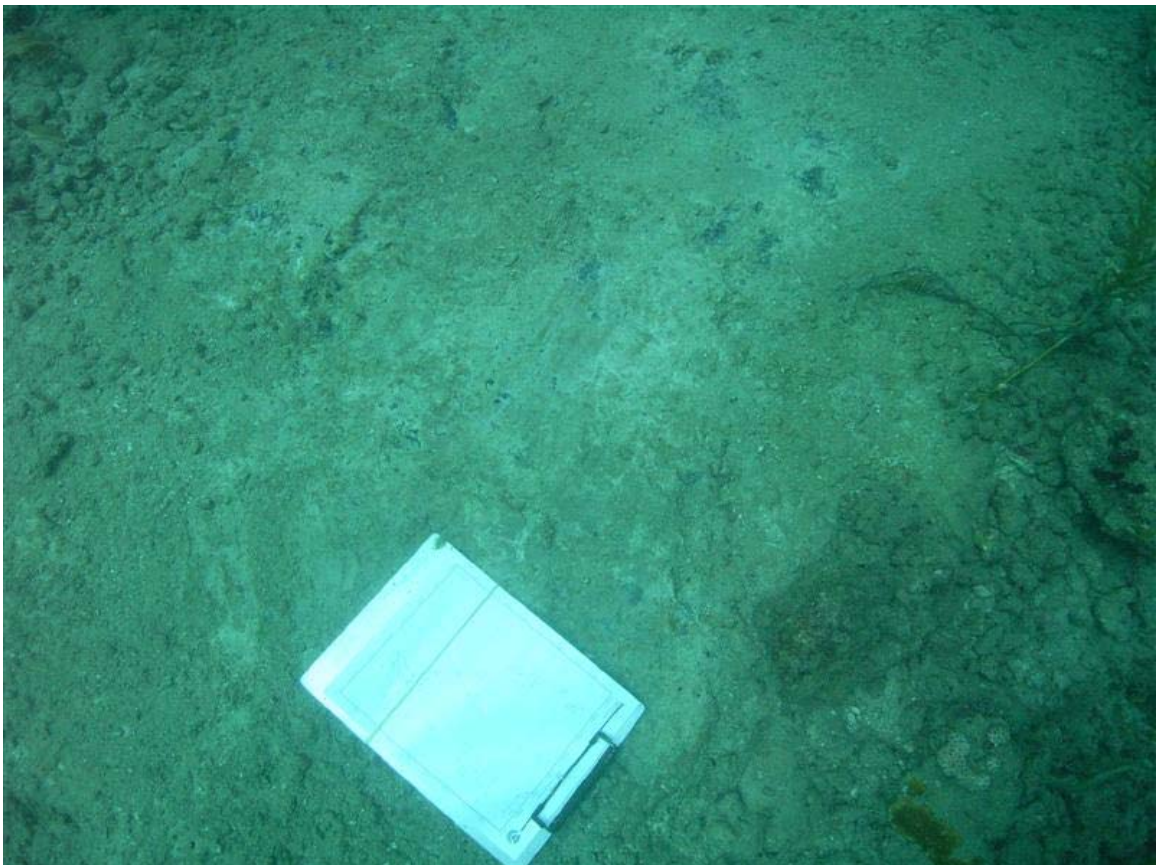
Figure 2b. Representative photos of remaining areas of anti-fouling paint at Site 146

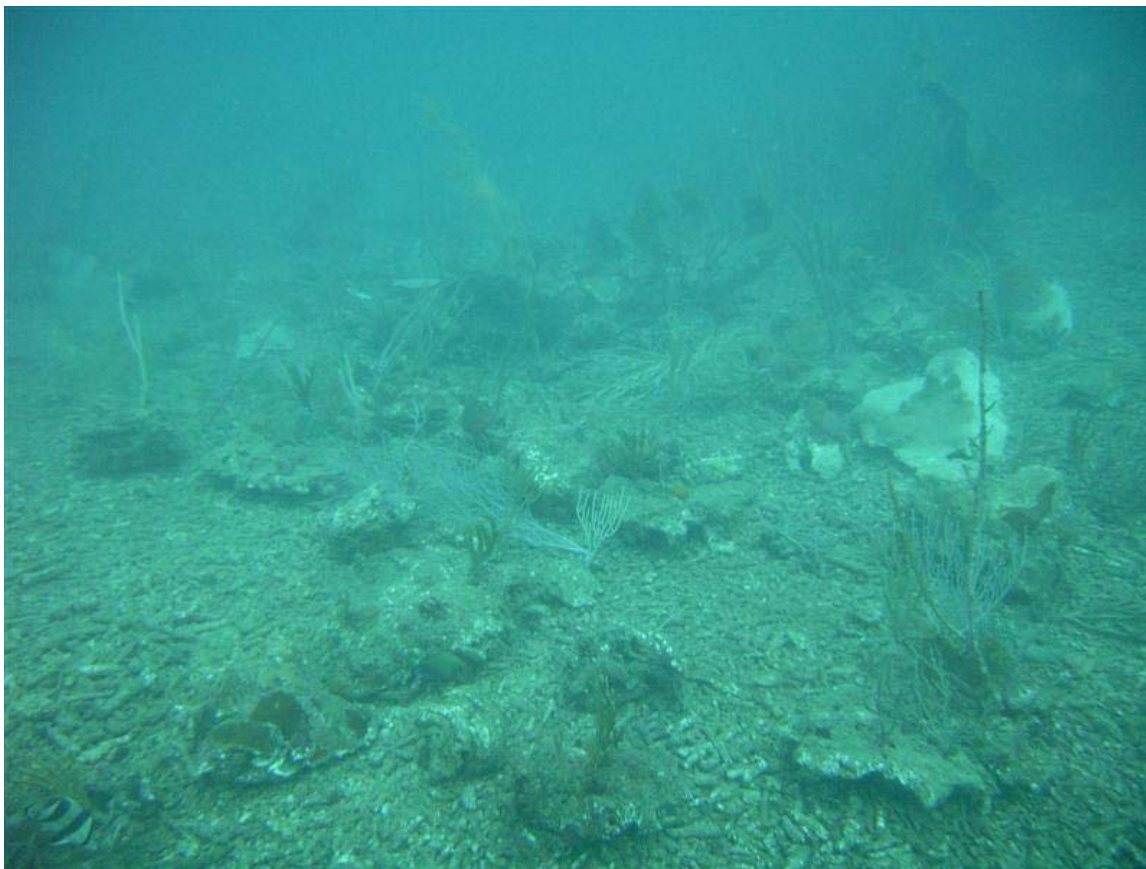
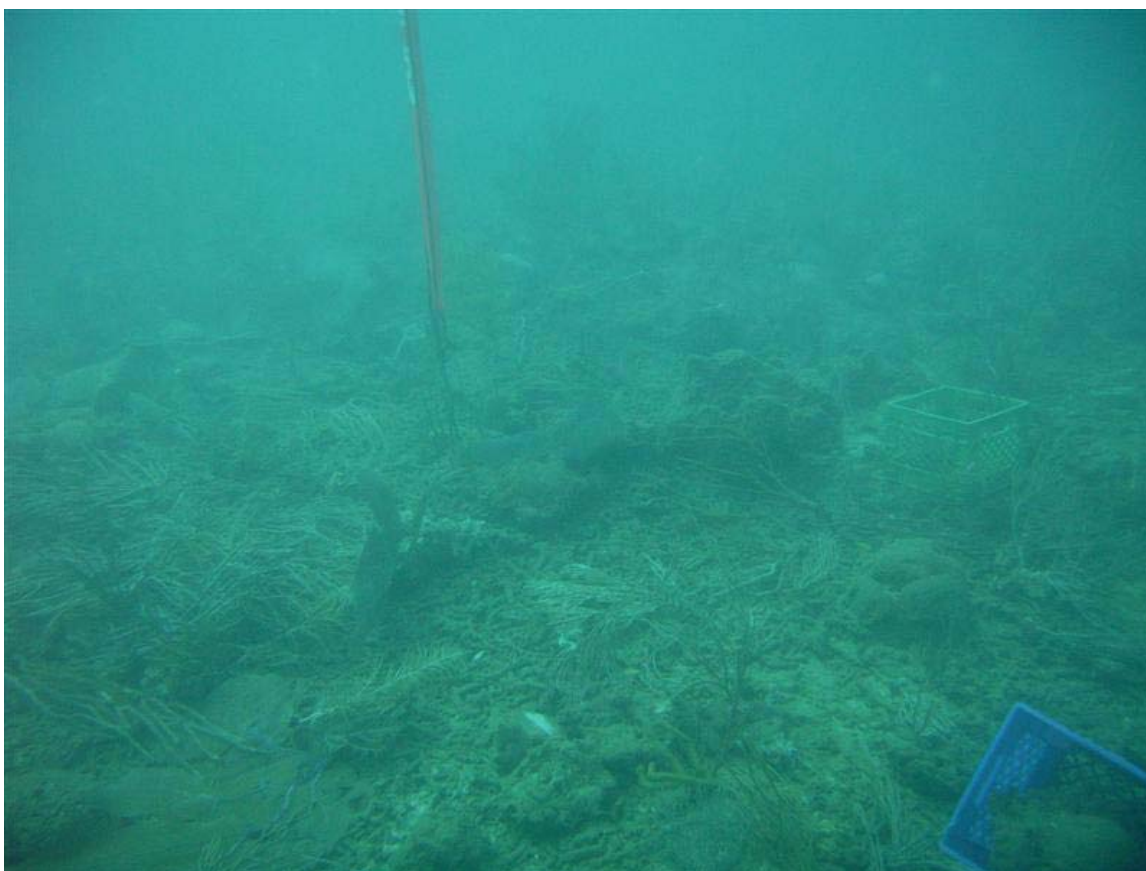
Approximately 150 hard coral pieces and 200-250 soft corals were cached that need to be reattached (see Figure 4). There is also additional anti-fouling paint that needs to be removed.

Figure 4. Photos of corals cached at Site 117.

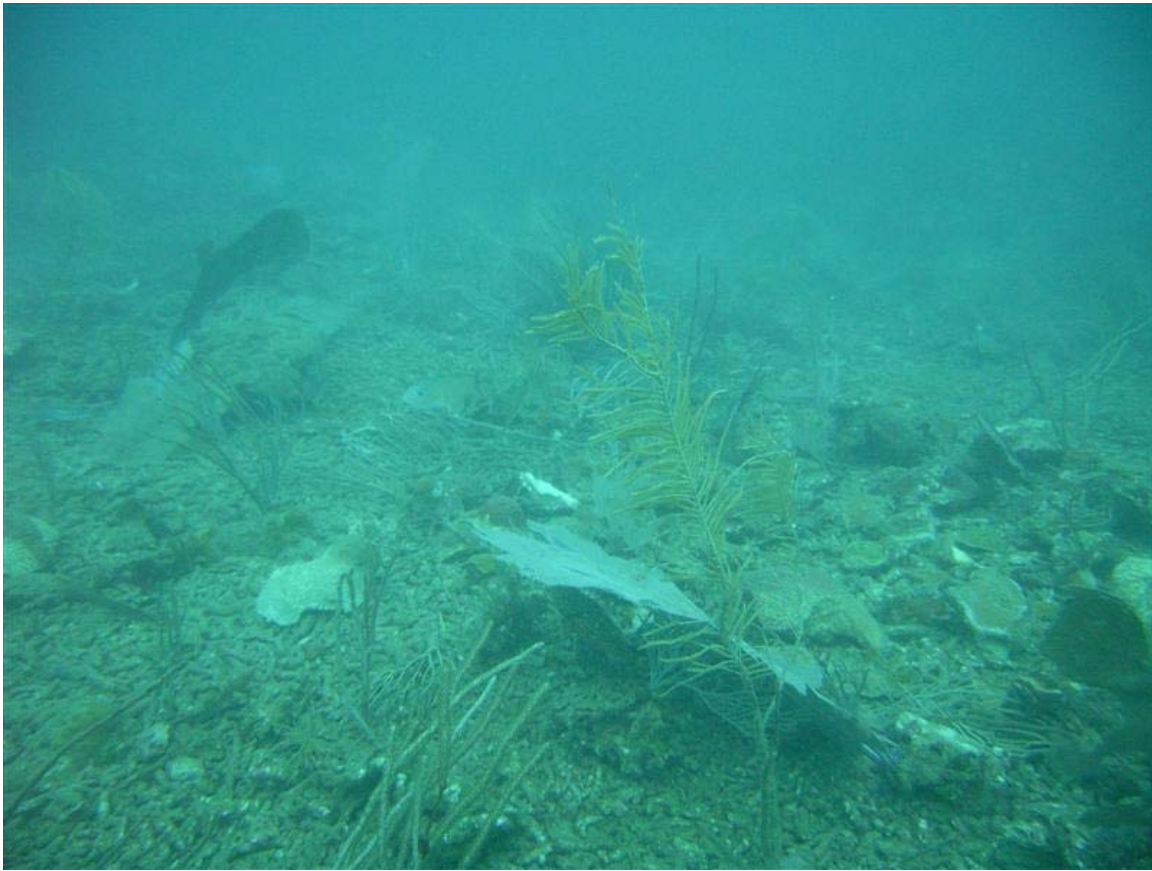
Approximately 100 hard coral pieces and 200-250 soft corals that need to be reattached were cached south of the marker (see Figure 5).

Figure 5. Corals cached south of Site 158.

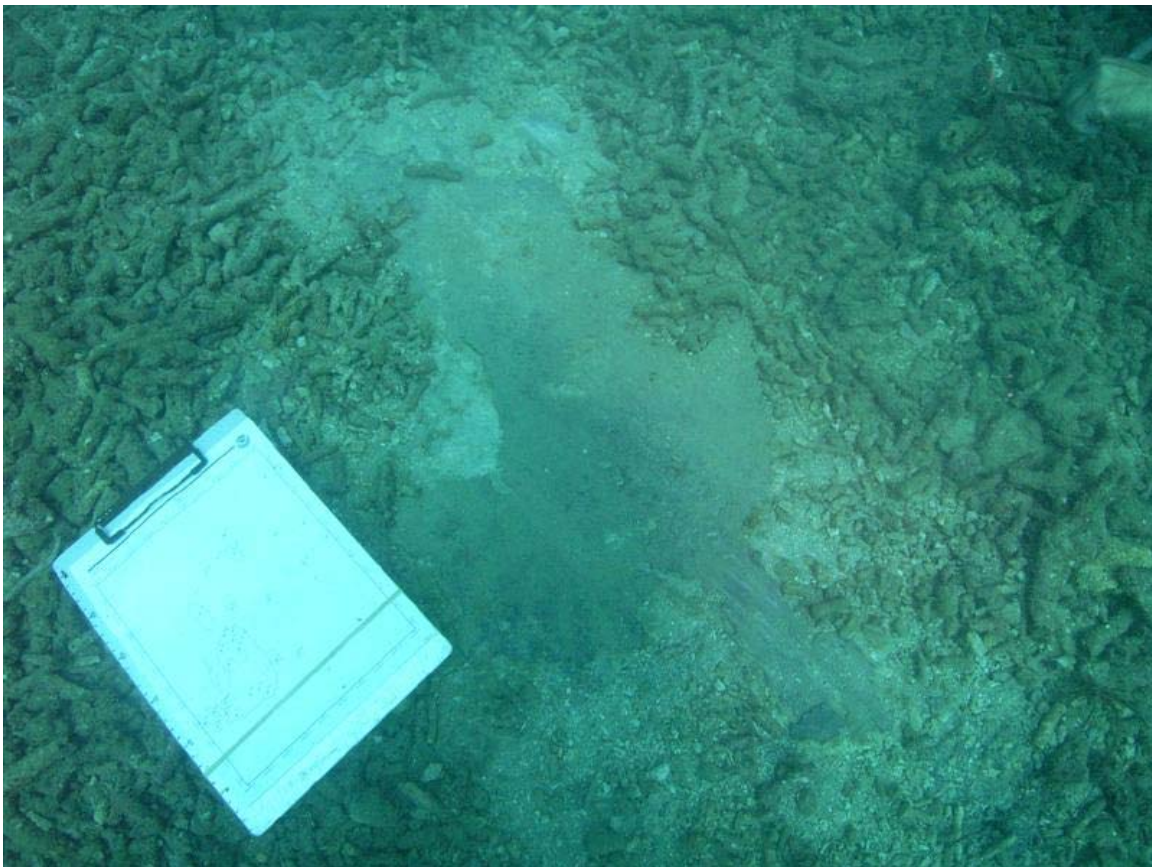
There is a 1 meter x 0.5 meter area of anti-fouling paint that needs to be removed (see Figure 6).

Figure 6. Area of anti-fouling paint that needs to be removed, at letter J in Figure 3.

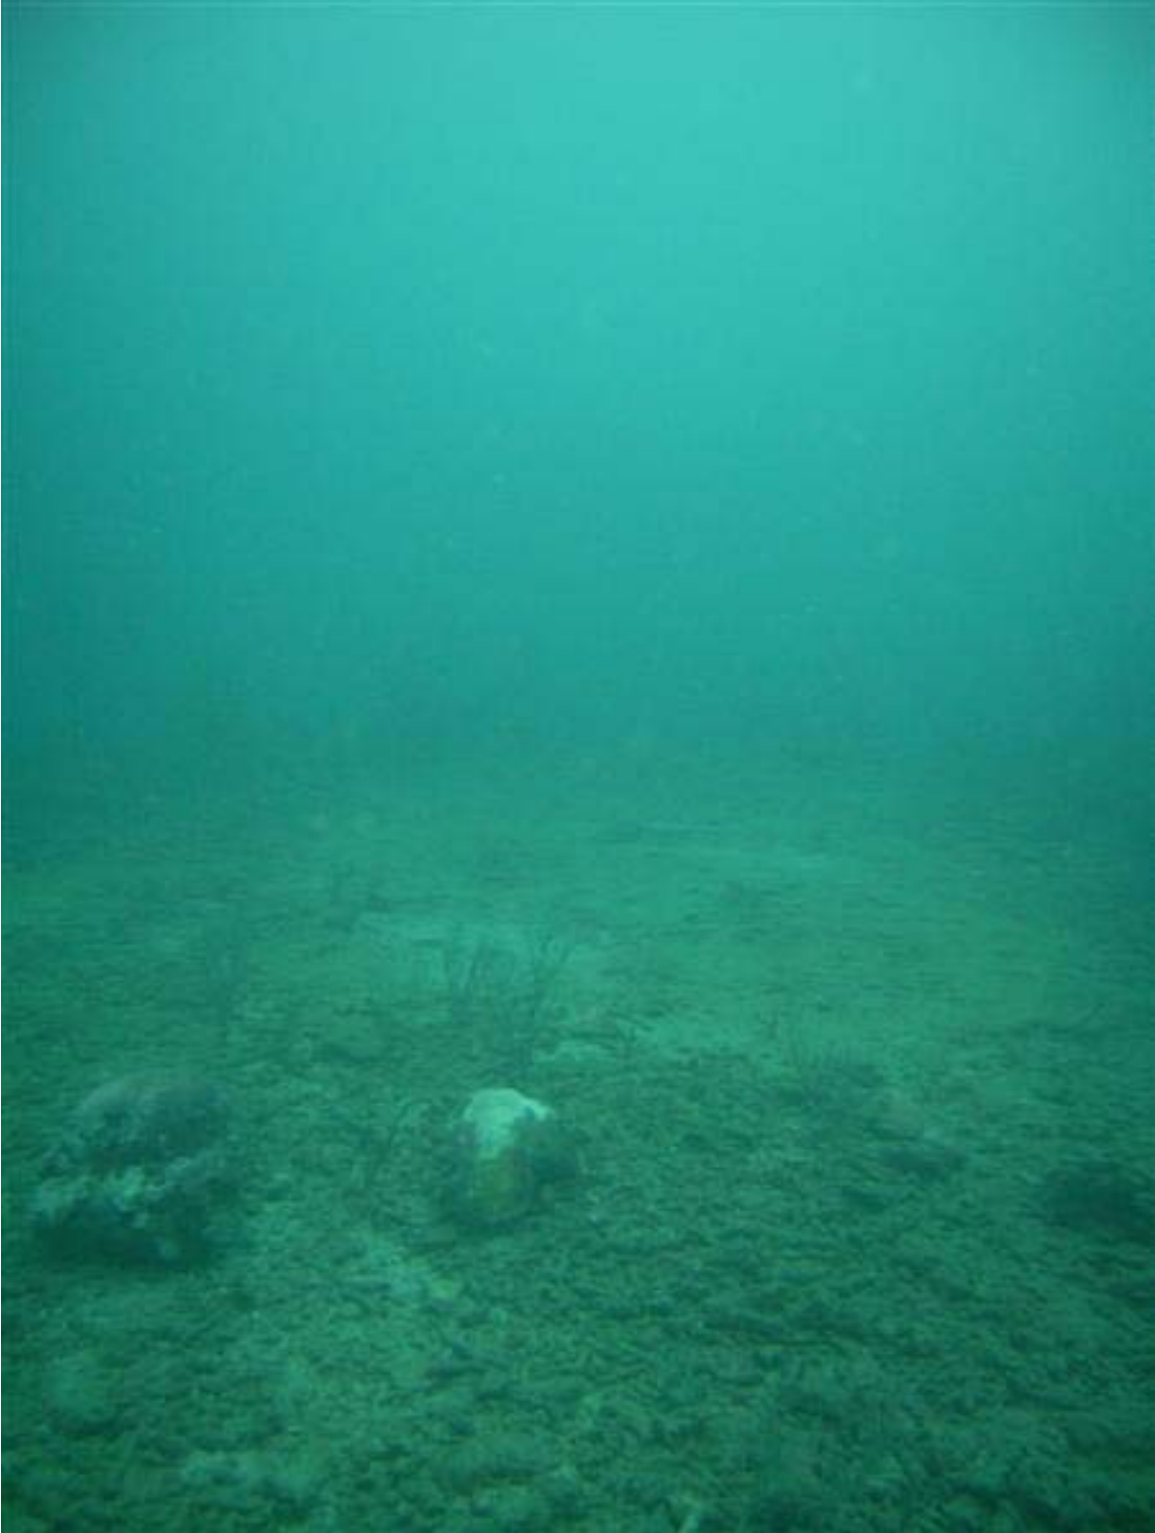
There is anti-fouling paint to be removed and coral to be reattached. The site was measured as 34' x 17' (10.4 m x 5.2 m). (see Figure 7 & 8)

Figure 7. Photo of Site T-15.

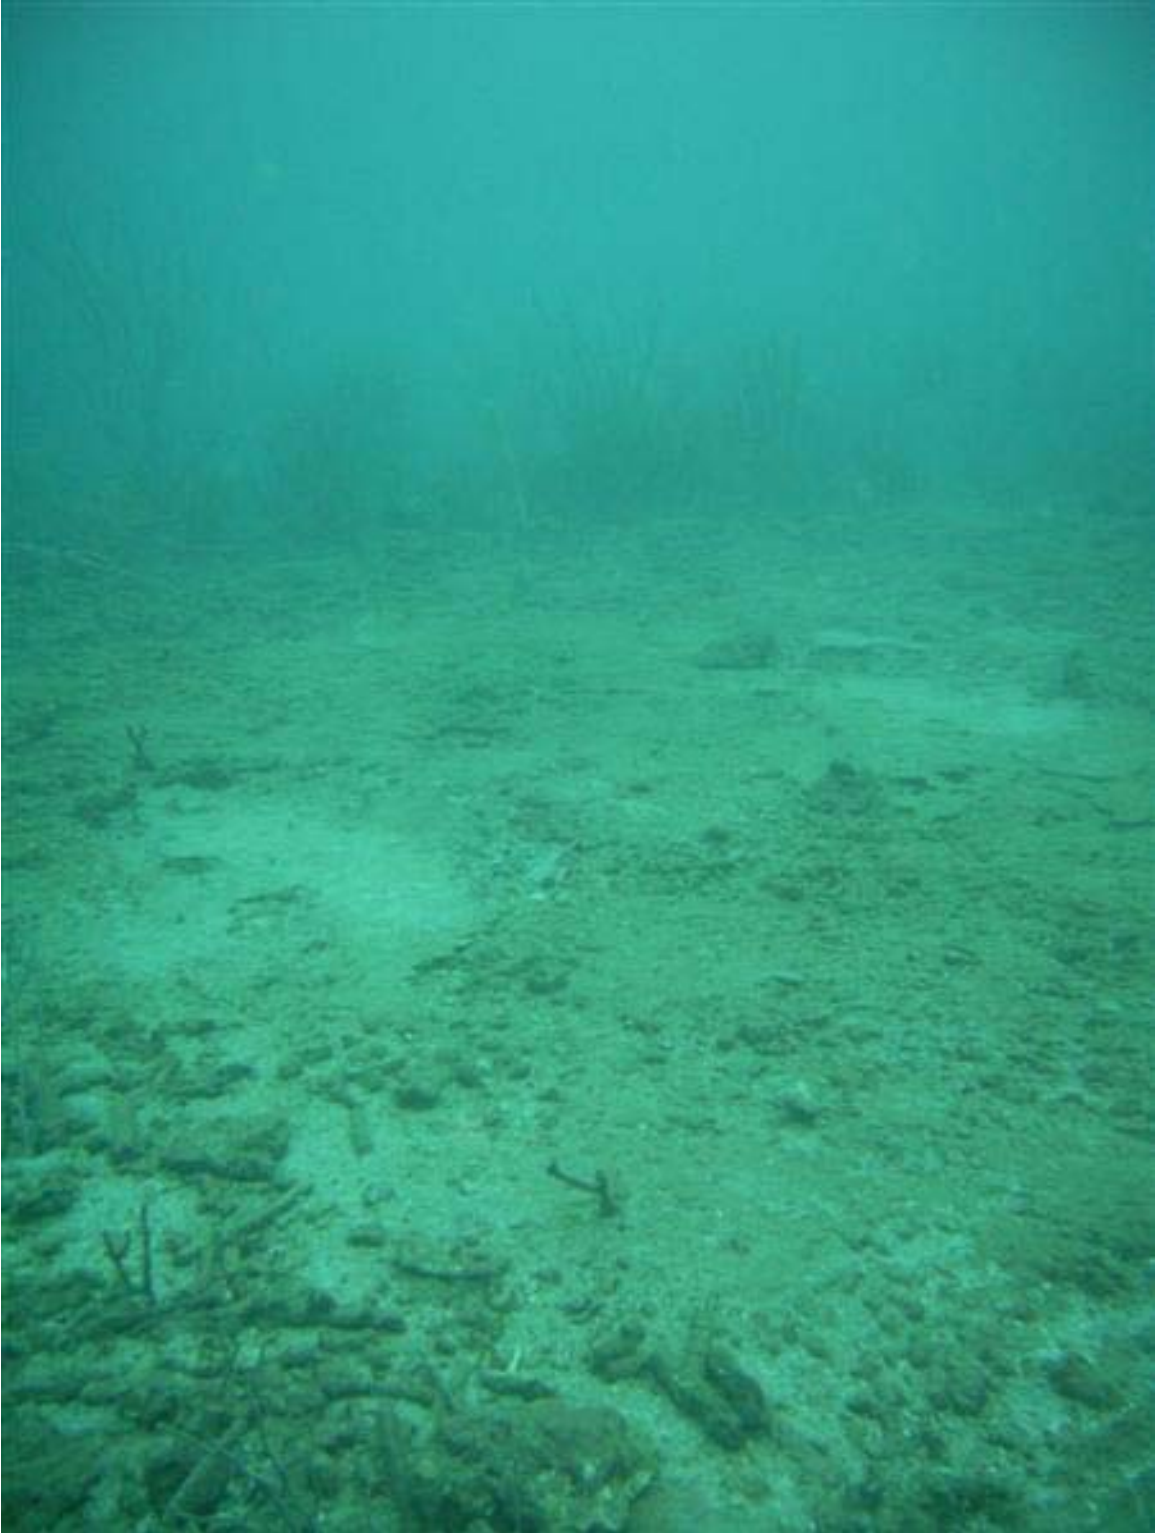
Figure 8. Close-up of Site T-15 showing areas of anti-fouling paint.
