# **Emergency Restoration Strategy: *M/T Margara* Grounding Offshore South Coast of Puerto Rico**

**September 2006**

Continental Shelf Associates, Inc.  
759 Parkway Street  
Jupiter, Florida 33477  
Telephone: (561) 746-7946

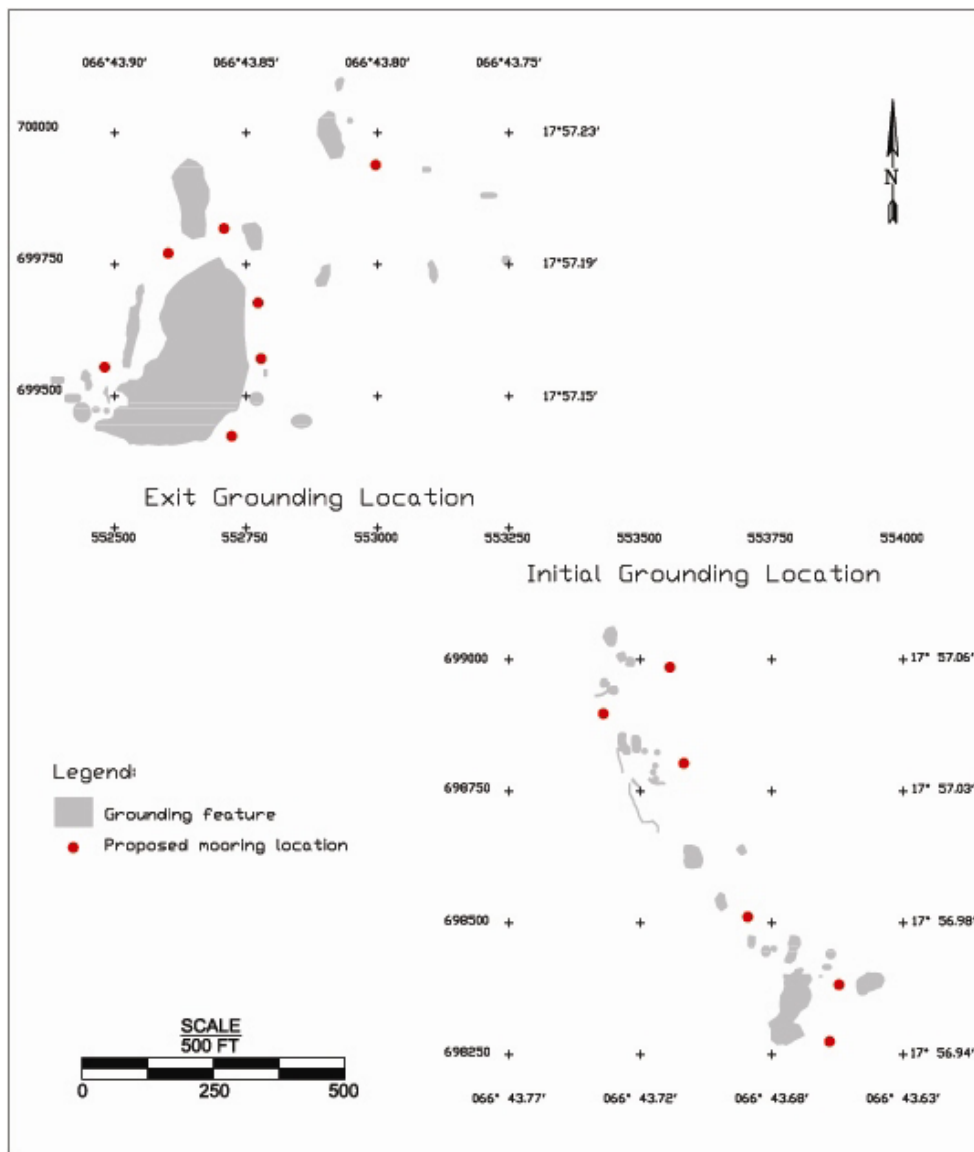
Figure 3. Proposed mooring locations relative to *M/T Margara* grounding features.

Mooring installation will be required in the vicinity of the grounding site to accommodate securing work vessels during restoration operations and will significantly reduce the potential for habitat impact due to vessel anchor deployment and recovery. Vessel moorings will be anchored to the seafloor at selected locations at the grounding site that are hard bottom substrate, relatively devoid of epibiota, and have spatial distribution around the grounding site to facilitate versatile positioning of work vessel(s). Vessel moorings will be marked with surface buoys. Proposed mooring locations relative to the *M/T Margara* grounding features are shown in **Figure 3**.

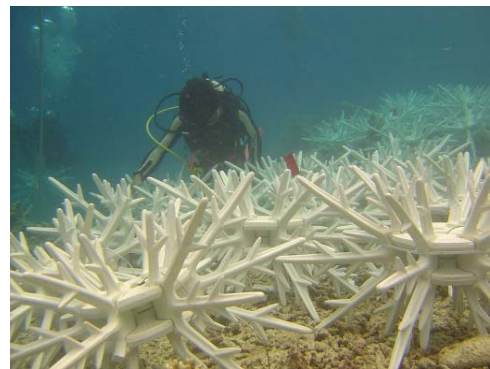
**EcoReefs** are interlocking ceramic artificial reef modules that mimic the growth form of branching corals and are considered as a suitable platform for reattachment of *A. cervicornis* fragments. Individual modules would be secured to the bottom using a combination of anchors and cement. An array of EcoReefs would be constructed of four to six interlocking modules. Each module could accommodate the reattachment of approximately 10 to 15 *A. cervicornis* fragments. Cable ties would be used to secure the individual *A. cervicornis* fragments to the ceramic modules.
