## **T/V *Margara* Emergency Restoration Inspection October 19-21, 2006**

A site inspection of the emergency restoration efforts led by Continental Shelf Associates and supported by Trustee staff at the impact sites of the T/V *Margara* was conducted from October 19-21, 2006 by the Trustees. The goal of the inspection was to determine if any additional work was required. The inspection team consisted of Craig Lilyestrom and Edwin Rodriguez (Puerto Rico Department of Natural & Environmental Resources), Michael Nemeth and Sean Griffin (Lighthouse Technical Consultants, Inc.), and Tom Moore and Kevin Kirsch (National Oceanic & Atmospheric Administration).

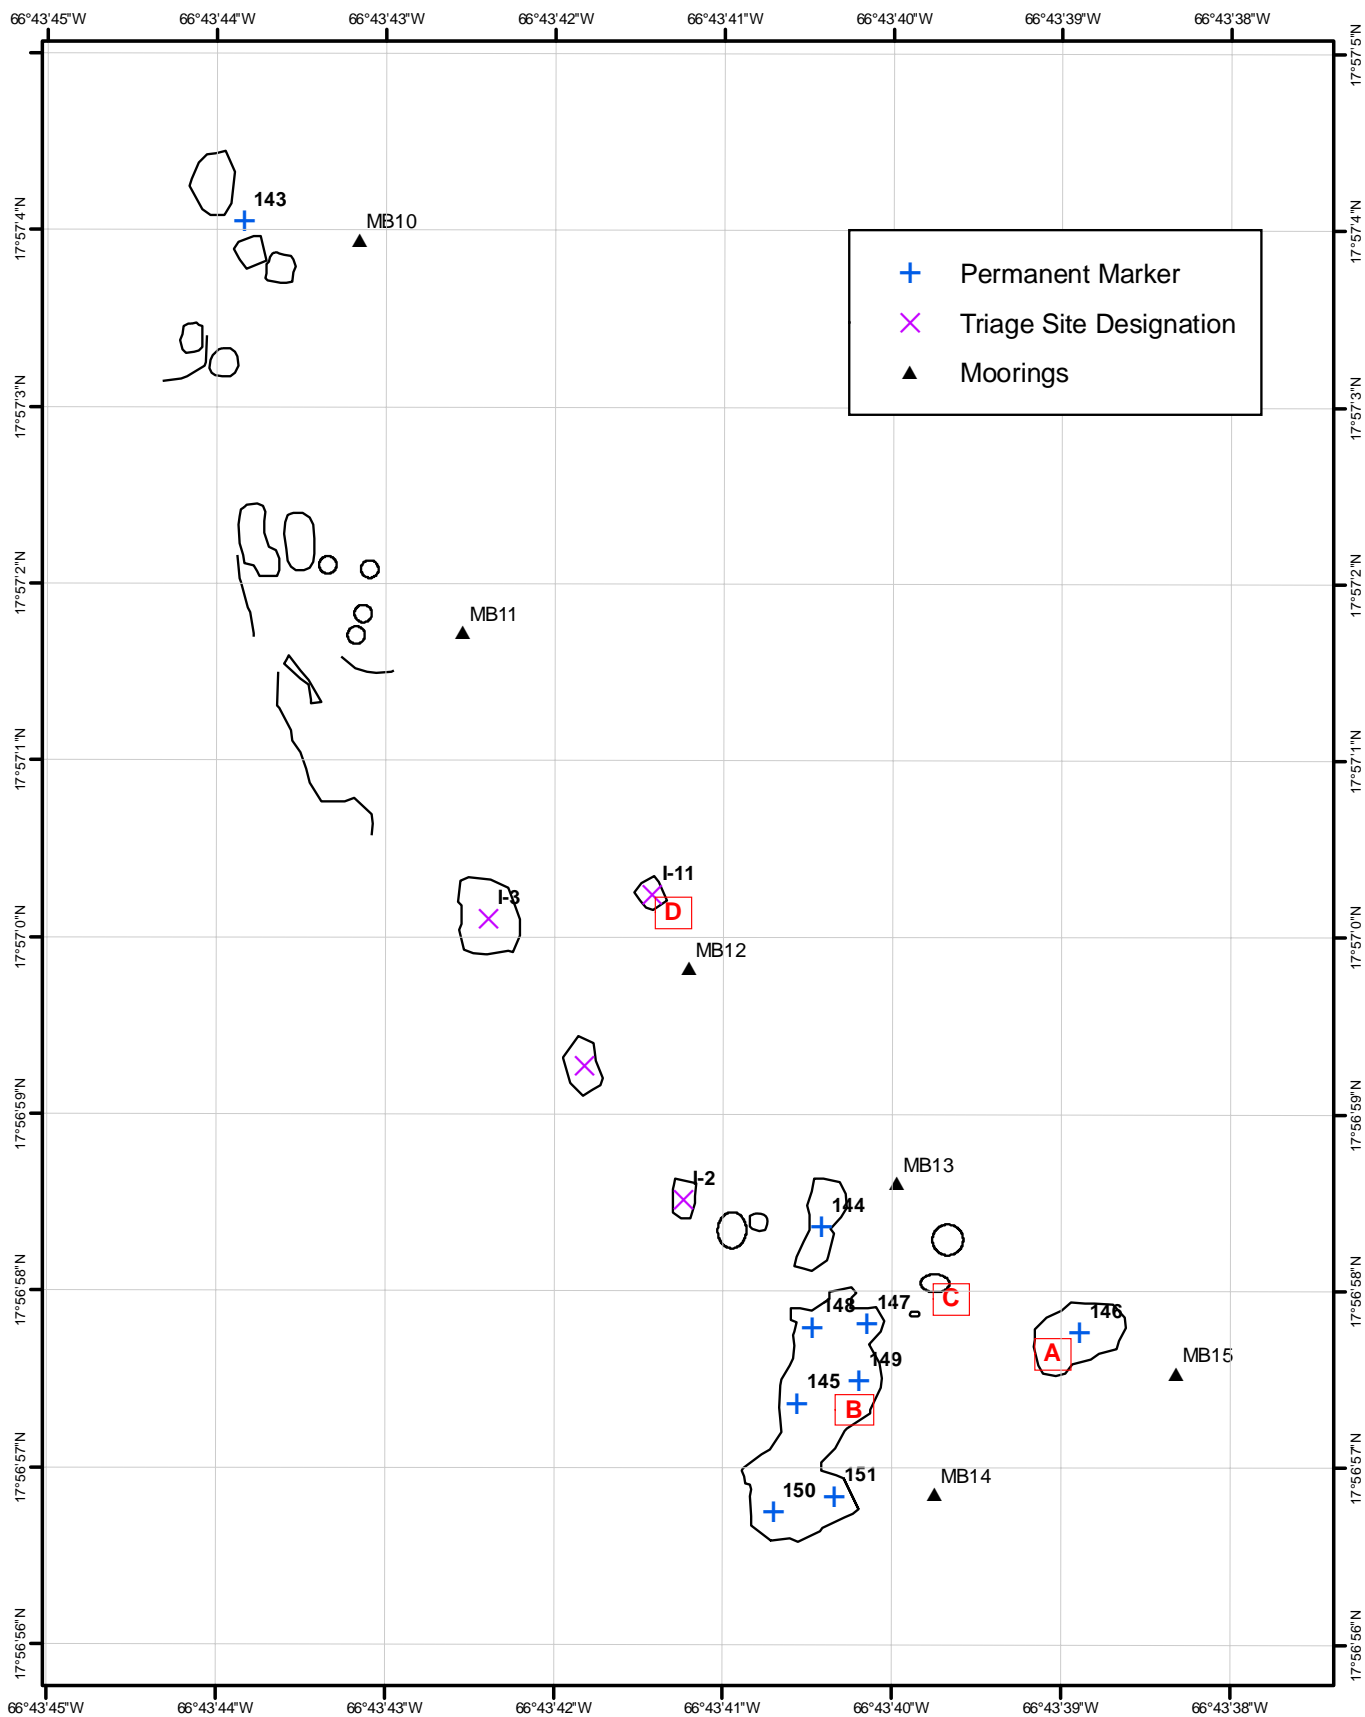
There are at least 5 areas where anti-fouling paint needs to be removed (see Figure 2a & b).

There is a small area (10 cm x 10 cm) of anti-fouling paint to be removed.

There are 5-6 patches, ~50 cm in diameter each, of anti-fouling paint that need to be removed. There are also 8 hard corals that need to be reattached.

Figure 1. Southern injury, red letters indicate areas where additional emergency restoration work is needed

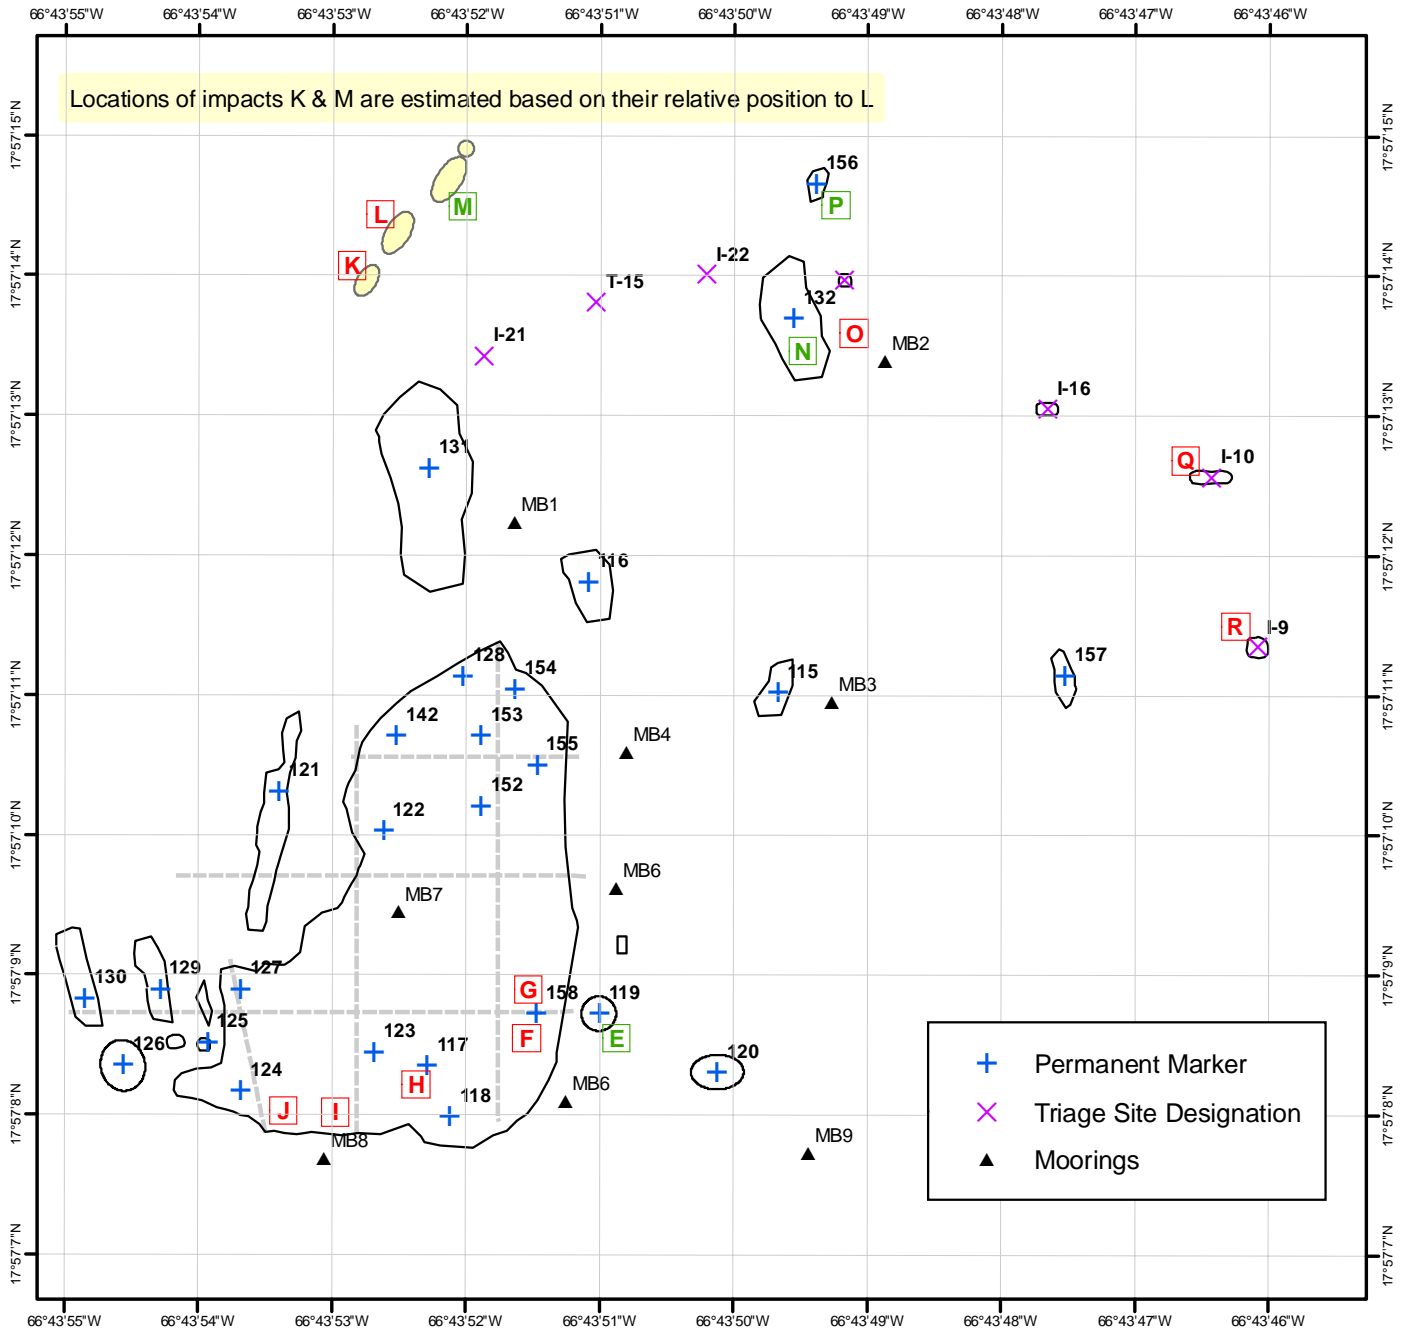
Figure 3. Northern injury; red letters indicate areas where additional emergency restoration work is needed; green letters indicate areas of note within the text.
